Manhole Inspection Summary

Manhole # S19CC1026MH

Location Address: **2154 DRUID PARK DR**

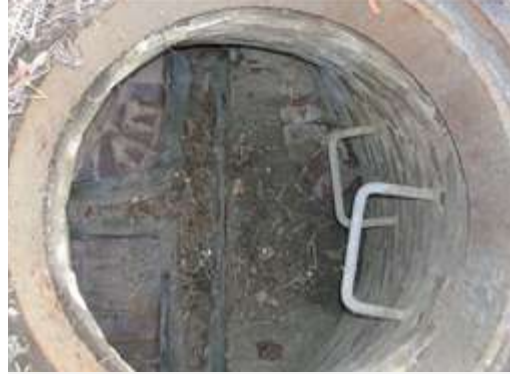
Top View

Bench and Channel debris.

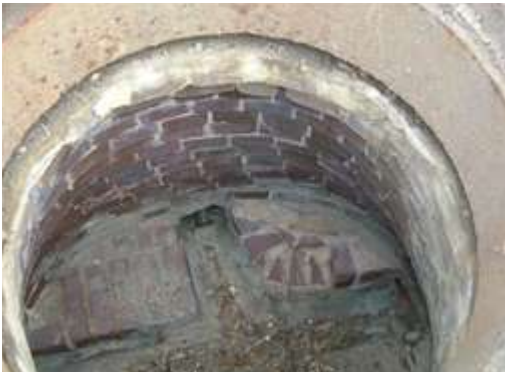
Defect

Frame leaks. Adjustment and Barrel infiltration

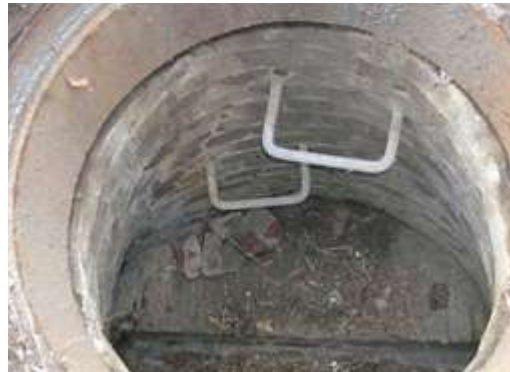
Defect

Frame leaks. Adjustment and Barrel infiltration.

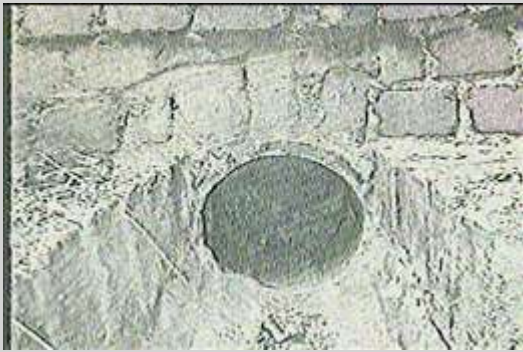
Pipe In @ 6 O'Clock

Barrel deterioration and infiltration. Channel deterioration.

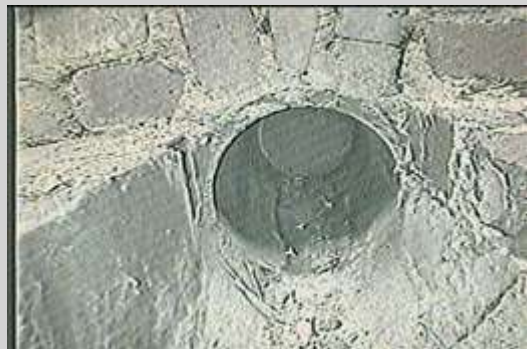
Pipe In @ 9 O'Clock

Channel deterioration.
